# Manhole Inspection Summary

Manhole # S33II\_002MH

Insp Date: **12/6/06 11:56 AM**

**Location** Address: **1722 CHARLES ST**

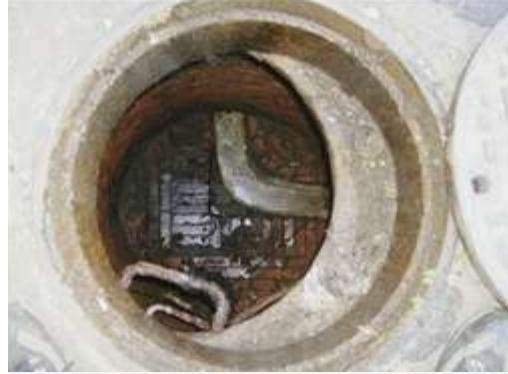
Top View

Barrel infiltration. Corroded steps.  
Evidence of surcharge - Bench debris.

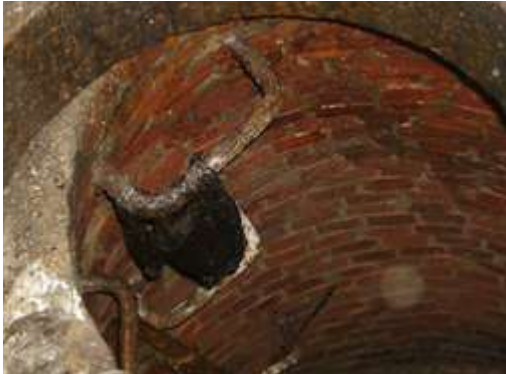
Defect

Frame leaks. Frame offset. Adjustment  
infiltration.

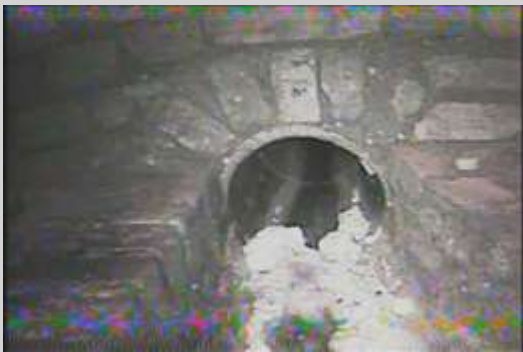
### 8 in. Circular Gravity Sewer Pipe Out @ 12 O'Clock

Deposits: ☐ None ☐ Mud ☐ ~~Gravy~~ ☐ Debris ☒ **Grease**

Silt Depth: **0** (in.) Deposits Extent: **Light**

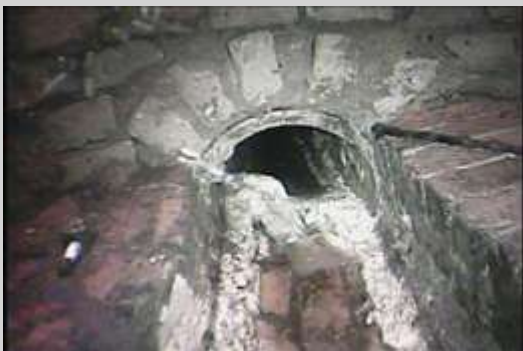
### 8 in. Circular Gravity Sewer Pipe In @ 3 O'Clock

Deposits: ☐ None ☐ Mud ☒ ~~Gravy~~ ☐ Debris ☒ **Grease**

Silt Depth: **2** (in.) Deposits Extent: **Medium**

Infiltration: **Evidence** Pipe Seal Cond: **Unknown**
